# Manhole Inspection Summary

Manhole # S21GG\_019MH

Insp Date: **3/17/09 2:34 PM**

**Location** Address: **1556 MCKEAN AVE**

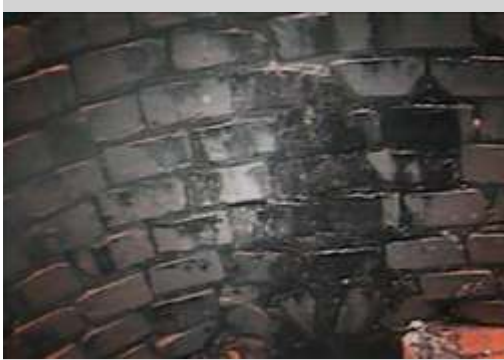
Defect 4

Infiltration: ☐ None ☐ Joint ☐ Cracks ☐ Mortar ☐ Roots ☒ **Wall**

INFILTRATION OF BARREL

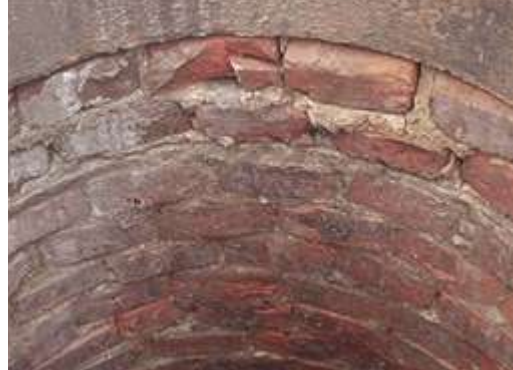
Defect 3

Condition: ☐ Sound ☐ Cracked ☐ Root Intrusion ☒ **Loose Brick** ☒ **Deteriorated**

DETERIORATION OF CORBEL

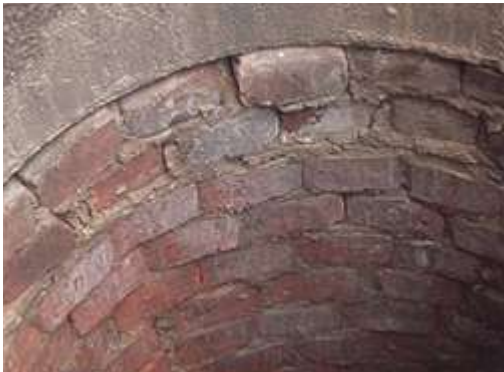
Defect 2

LOOSE CORBEL BRICKS

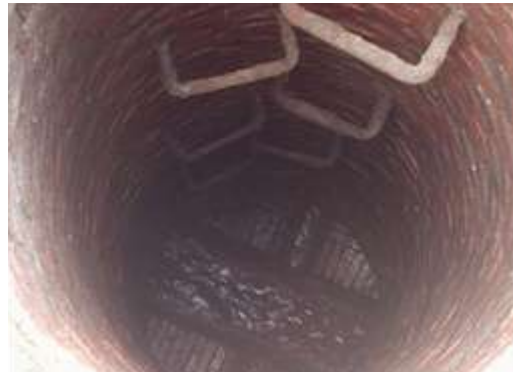
Defect 1

Count: **10** Missing: **0** ☒ **Corroded**

CORRODED STEPS

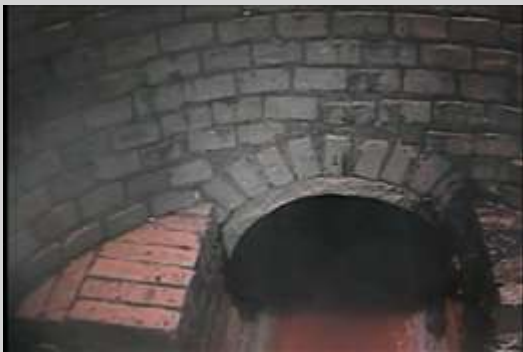
12 O'Clock Outflow

Pipe Height: **24** (in.) Rod and Bar (Angled)  
Pipe Material: **Clay** ☐ Pipe Lined  
Invert Depth: **21.64** (ft.) Flow Characteristics: **Fast**  
Deposits: ☒ None ☐ Mud ☐ Sludge ☐ Debris ☐ Grease  
Silt Depth: (in.) Deposits Extent:  
Infiltration: **None** Pipe Seal Cond: **Sound**

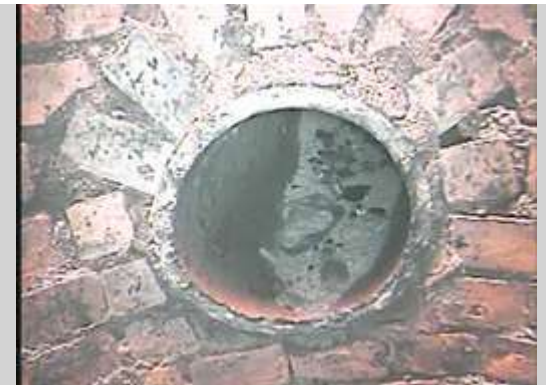
3 O'Clock Inflow

Pipe Height: **8.4** (in.) Rod and Bar (Angled)  
Pipe Material: **Clay** ☐ Pipe Lined  
Invert Depth: **7.64** (ft.) Flow Characteristics: **Fast**  
Deposits: ☒ None ☐ Mud ☐ Sludge ☐ Debris ☐ Grease  
Silt Depth: (in.) Deposits Extent:  
Infiltration: **None** Pipe Seal Cond: **Sound**

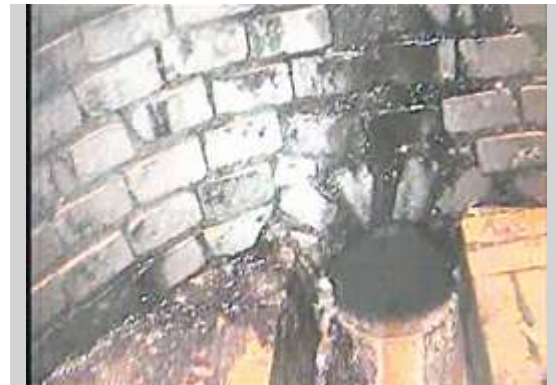
Drop In @ 3 O'Clock

Drop: **Outside** Rod and Bar  
Angled: **Yes** Reading: **19.34** (ft.)  
Inv Depth: **20.34** (ft.)  
Drop Condition: **Open**

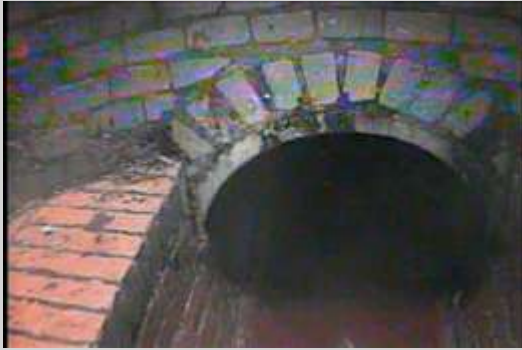
6 O'Clock Inflow

Infiltration: **None** Pipe Seal Cond: **Sound**

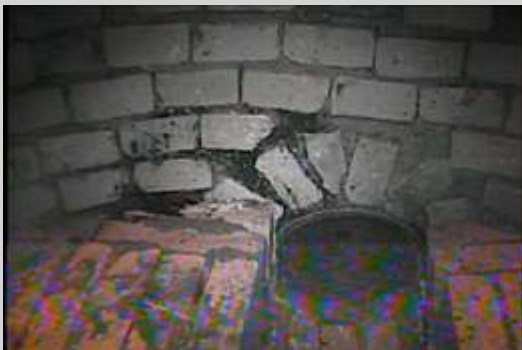
9 O'Clock Inflow

Infiltration: **None** Pipe Seal Cond: **Sound**

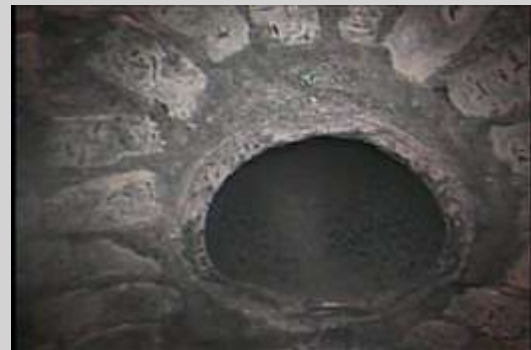
Drop In @ 9 O'Clock

Drop: **Outside** Rod and Bar  
Angled: **Yes** Reading: **19.43** (ft.)  
Inv Depth: **20.43** (ft.)  
Drop Condition: **Open**
